## **North Coast Streams Limit of Anadromy**

City of Santa Cruz Water Department  
Chris Berry, Project Manager  
715 Graham Hill Road  
Santa Cruz, CA 95060-1410

Jeff Hagar, Hagar Environmental Science  
Ezekiel Bean, City of Santa Cruz Water Department  
Chris Berry, City of Santa Cruz Water Department

August 23, 2017

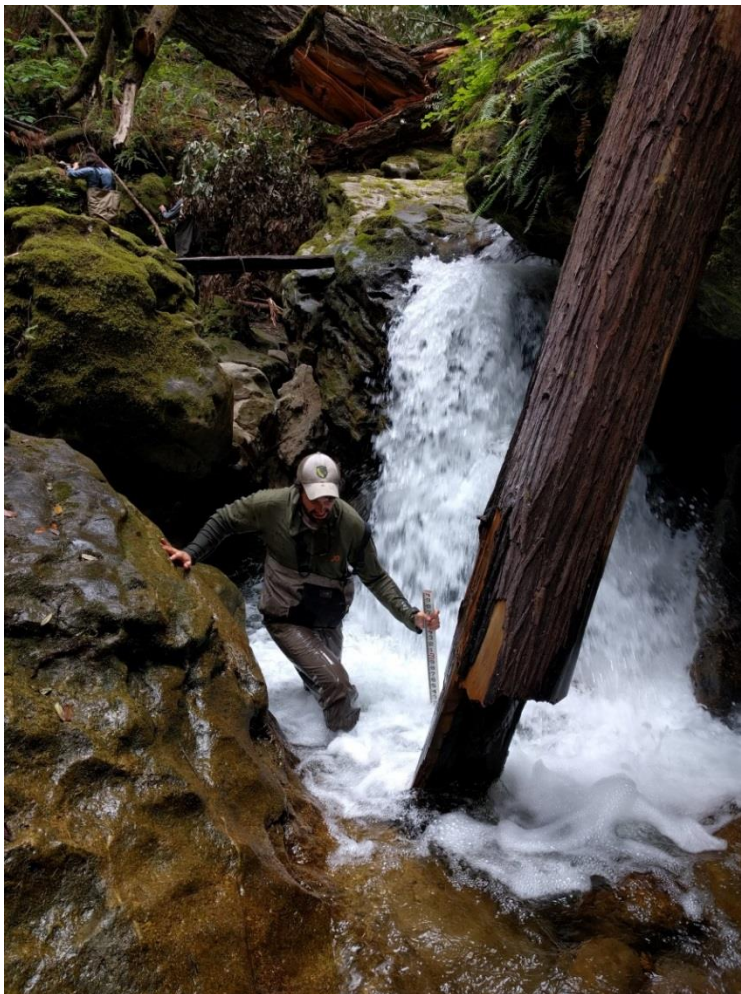
The channel from the Laguna Creek mouth to a point about 1.43 miles upstream is low gradient (~1.5 percent) and moderately confined. At this point (near Y Creek confluence), a series of large boulders fills the channel and forms at least one major cascade (Figure 2). This location forms a barrier to anadromous fish passage.

Figure 2. Boulder falls in Laguna Creek at Y Creek confluence.

Environmental Science. The team concluded that there may be some flows where adult steelhead could ascend the boulder fall but that the frequency of such events would be insufficient to support an anadromous population upstream. City staff followed up with stream channel slope surveys subsequent to this site visit. Measurements were taken over a 90 foot section including the steepest section with cascade and 2-3 channel widths upstream and downstream of the high gradient section (Figure 3). The overall 90 ft. section had a gradient of 11.5 percent while the steepest 43 foot portion had a gradient of 28%, including one significant jump of 8.61 feet (streamflow approximately 7 cfs at the anadromous stream gage).

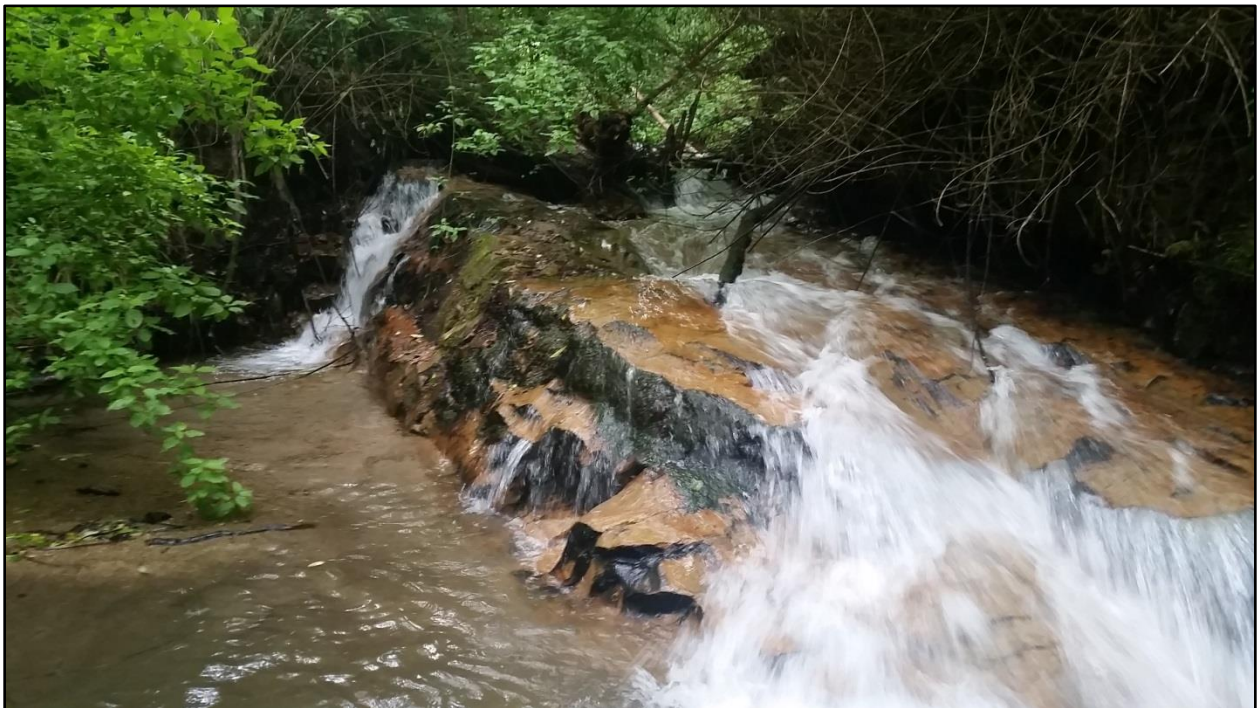
In Liddell Creek a natural migration barrier is formed where the stream passes over a bedrock ledge about 1.16 miles upstream from the mouth and 0.13 miles downstream of the confluence of the East Branch with the Middle Branch<sup>2</sup>. Observations were made at this site on May 24, 2017 by a team of biologists and engineers from California Department of Fish and Wildlife, NOAA Fisheries, City of Santa Cruz, and Hagar Environmental Science. Flow at the time of the survey was approximately 5 cfs at the anadromous gage. The ledge was approximately 30 feet in length with a slope of about 14% in the downstream direction (Figure 4).

Figure 4. Bedrock ledge in Liddell Creek 1.16 miles from mouth.

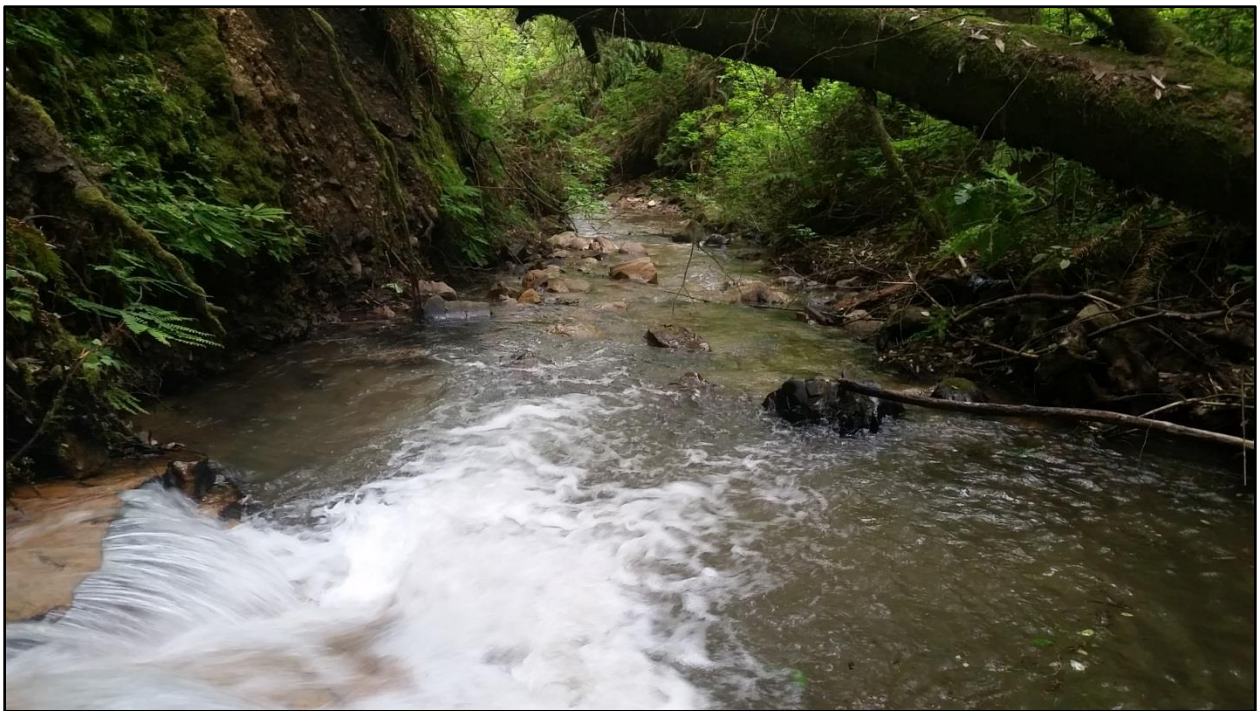
At the lower end of the bedrock shelf there was a 2 foot drop with maximum depth of flow of only about 1.5 feet in the stream immediately below it. The stream channel cuts upstream along the edge of the bedrock on the west side, with another cascade at the top. This upper cascade had a vertical drop of about 6 feet with no pool and shallow depth of flow below. There was a debris jam at the top of the ledge. Average depth of flow across the bedrock ledge was 0.5 feet. The downstream channel was relatively unconfined and there was no indication on the banks of significant backwatering below the ledge (Figure 5). This location was judged to be a total barrier to migration of all life-stages of steelhead and coho salmon and the limit of anadromy in Liddell Creek.

Figure 5. Stream channel downstream of Liddell bedrock ledge.

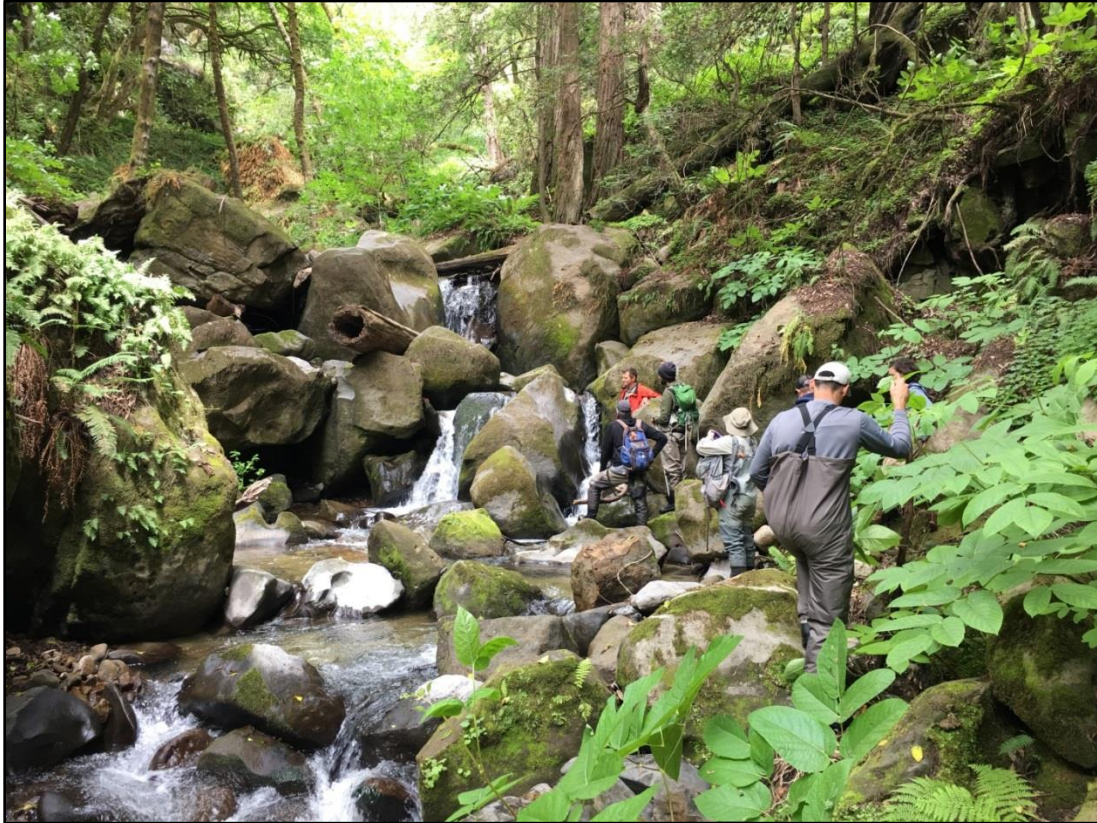
About 0.7 miles upstream of the mouth, Majors Creek enters a short reach (0.15 mi) of very steep (>10 percent gradient) bedrock and boulder cascades. This reach forms a barrier for fish passage at a distance of 0.71 miles upstream from the creek mouth (Figure 6).

Figure 6. Beginning of boulder cascades in Majors Creek.

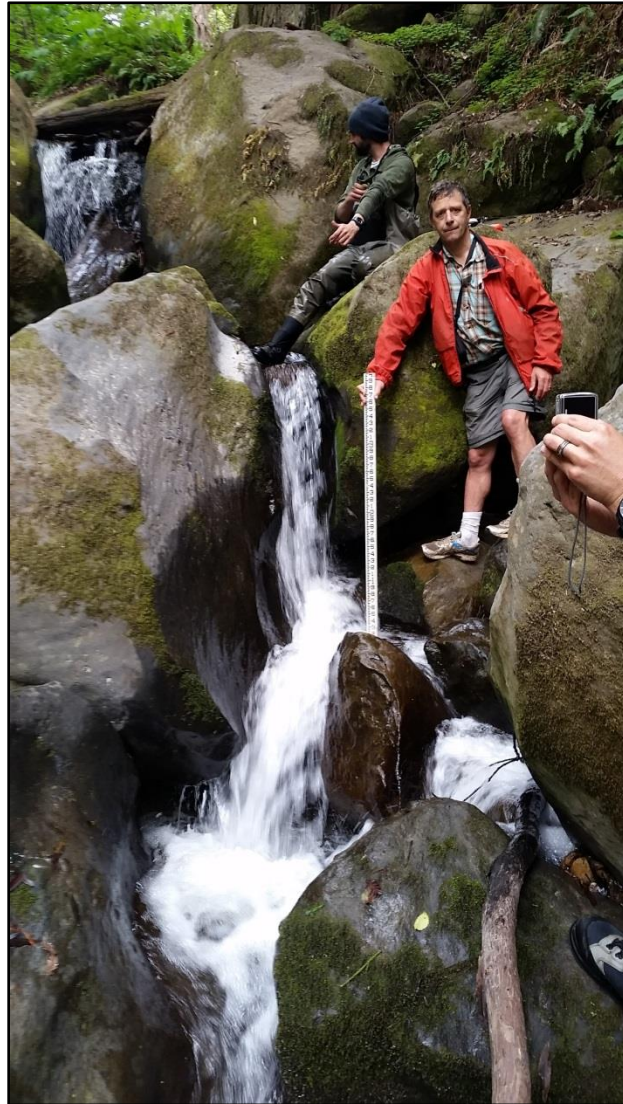
The initial cascade drops 18 feet over a distance of 49 feet (Figure 8). The pool below this cascade was 3 feet deep at its deepest point. Although there may be some backwatering below the cascades at higher flows the channel immediately downstream of the lower cascade is relatively steep, limiting the potential increase in stage (Figure 9). Measurements off USGS topographic map show a 28% gradient over a distance of 630 feet in the vicinity of these cascades.

Figure 8. Initial cascade in Majors Creek boulder cascade complex.

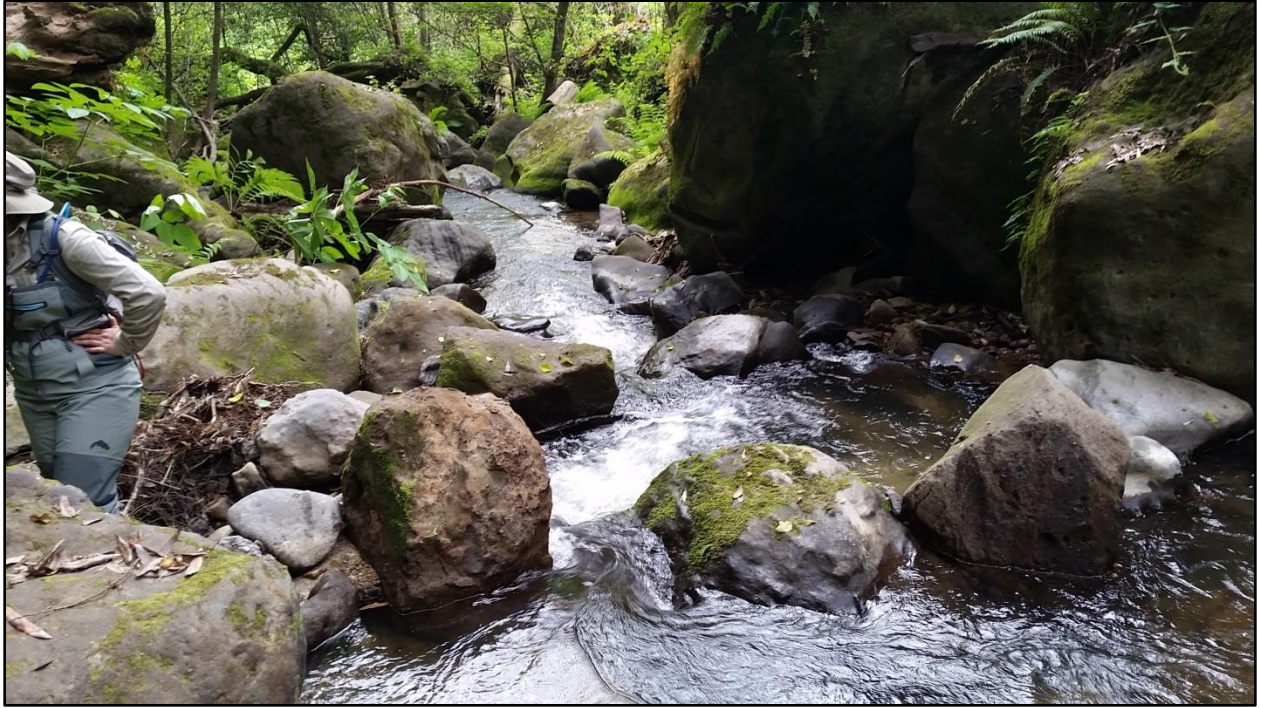
Figure 9. Stream reach immediately downstream of Majors Creek boulder cascade complex.

The stream section was judged a total barrier to all life-stages of steelhead and coho salmon under conditions at the time of observation. There may be passages that open during certain high flow conditions that would allow an individual steelhead to occasionally ascend through this section. However, such conditions would likely occur infrequently and the overall extended steep gradient of this section, the number and complexity of obstacles, and the likely infrequent periods when flow conditions would allow ascent, support the conclusion that this would be considered the limit of anadromy in Majors Creek. The California Salmonid Stream Habitat Restoration Manual considers the limit of anadromy to be a sustained channel slope of eight to ten percent (Flossi et al. citing Robison et al. 2000 and SSHEAR 1998).
