State of California - The Resources Agency
DEPARTMENT OF PARKS AND RECREATION
PRIMARY RECORD

Page 1 of 4 *Resource Name or # (Assigned by recorder): Santa Cruz Market

c. Address: 214 California Ave. City Santa Cruz Zip 95060

Santa Cruz Historic Building Survey - Vol. III, Department of Planning and Community Development, City of Santa Cruz, 2012.

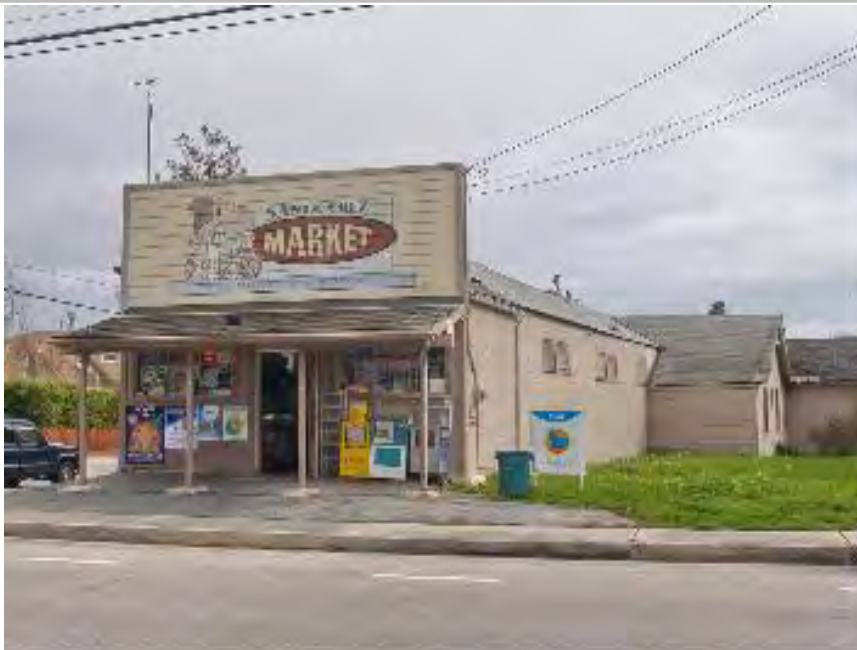
The Santa Cruz Market is located at 214 California Ave/, at the southwest corner of California Avenue and Walk Circle. Constructed in 1908, this Western False Front building is of wood frame construction with a stucco cladding that covers the original siding, and is sited on a narrow lot. The majority of the building's massing is contained within the overall rectangular plan. Composition shingles cover the roof which is concealed from view on the northwest elevation by a raised parapet or false front. Attached to the original structure at the rear of the building are what appear to be two historic (pre-1952) additions, both of which are clad in stucco. One of the additions appears to be a garage and the other a residence. The façade was damaged in the 1989 Loma Prieta Earthquake, but was quickly restored in 1990.

P5b. Description of Photo:
(View, date, accession #)
View facing south, 2009.

In 1990, after damages were incurred during the 1989 Loma Prieta Earthquake, the front façade was restored. The front entrance consists of a front door flanked by two large, six-light windows. Both hopper and awning-style windows fenestrate the building. Located on California Avenue, which is primarily a residential neighborhood, this commercial building is a dominant feature which stands out along the streetscape.
