State of California - The Resources Agency
DEPARTMENT OF PARKS AND RECREATION
PRIMARY RECORD

Page 1 of 4 *Resource Name or # (Assigned by recorder): Heath House/Advent Church Rectory
P1. Other identifier: None

c. Address: 120 Maple St.

Santa Cruz Historic Building Survey - Vol. III, Department of Planning and Community Development, City of Santa Cruz, 2012.

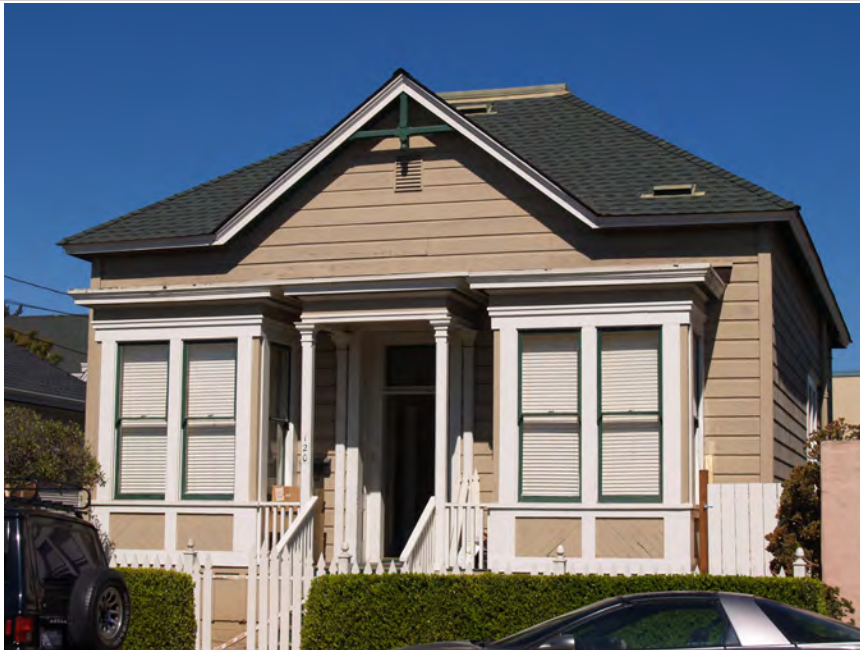
The unusual configuration of the symmetrical square bay windows, which flank the centered front porch, set apart this vernacular cottage from other late nineteenth century Stick style designs. This house includes typical features of this style, such as the king-post trusses at the gable ends, the truncated pyramidal roof, diagonal panels beneath the bay window sash, narrow windows, channel-rustic siding, beveled porch posts, and boxed eaves. The compact form, original materials, and distinctive detailing create a unique local design within the City of Santa Cruz.

P5b. Description of Photo:
(View, date, accession #)
View facing north, 2009.
