PRIMARY RECORD

Page 1 of 4 *Resource Name or # (Assigned by recorder): Bruce-Pait House

Santa Cruz Historic Building Survey - Vol. III, Department of Planning and Community Development, City of Santa Cruz, 2012.

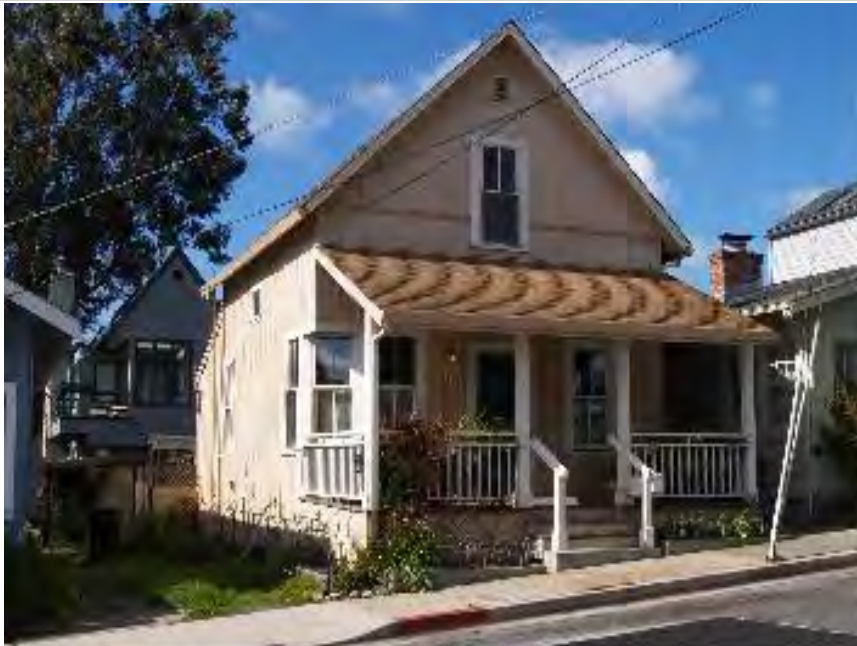
Although altered by replacement siding, many elements and details of this vernacular National style house at 111 Mott Ave. indicate that it was built sometime in the 1890s. The one-and-one-half-story house is constructed in a roughly symmetrical design and has a steeply pitched gable roof with a full-width front porch. The house features narrow 2/2 double-hung windows with slender muntins and a distinctive angled, tripartite window at the corner, similar to a bay window, which offered a view to Seabright Beach at the end of Mott Avenue. This house was constructed as a summer home, and sits within a neighborhood of similar scaled beach houses that has developed over an extended period of time, containing both old and new buildings of similar proportions. The single car garage that was previously associated with the property was demolished in 1971. Recent alterations to the building include a new foundation, a remodeled interior, repairs to the front and back porches, and replacement of the exterior wall cladding in 1992.

P5b. Description of Photo:
(View, date, accession #)
View facing west, 2009.
